REVIVAL OF DEGRADED ECOSYSTEM THROUGH ECOLOGICAL INTERVENTIONS: A SUCCESS STORY OF MURI, JHARKHAND

Background of the Site

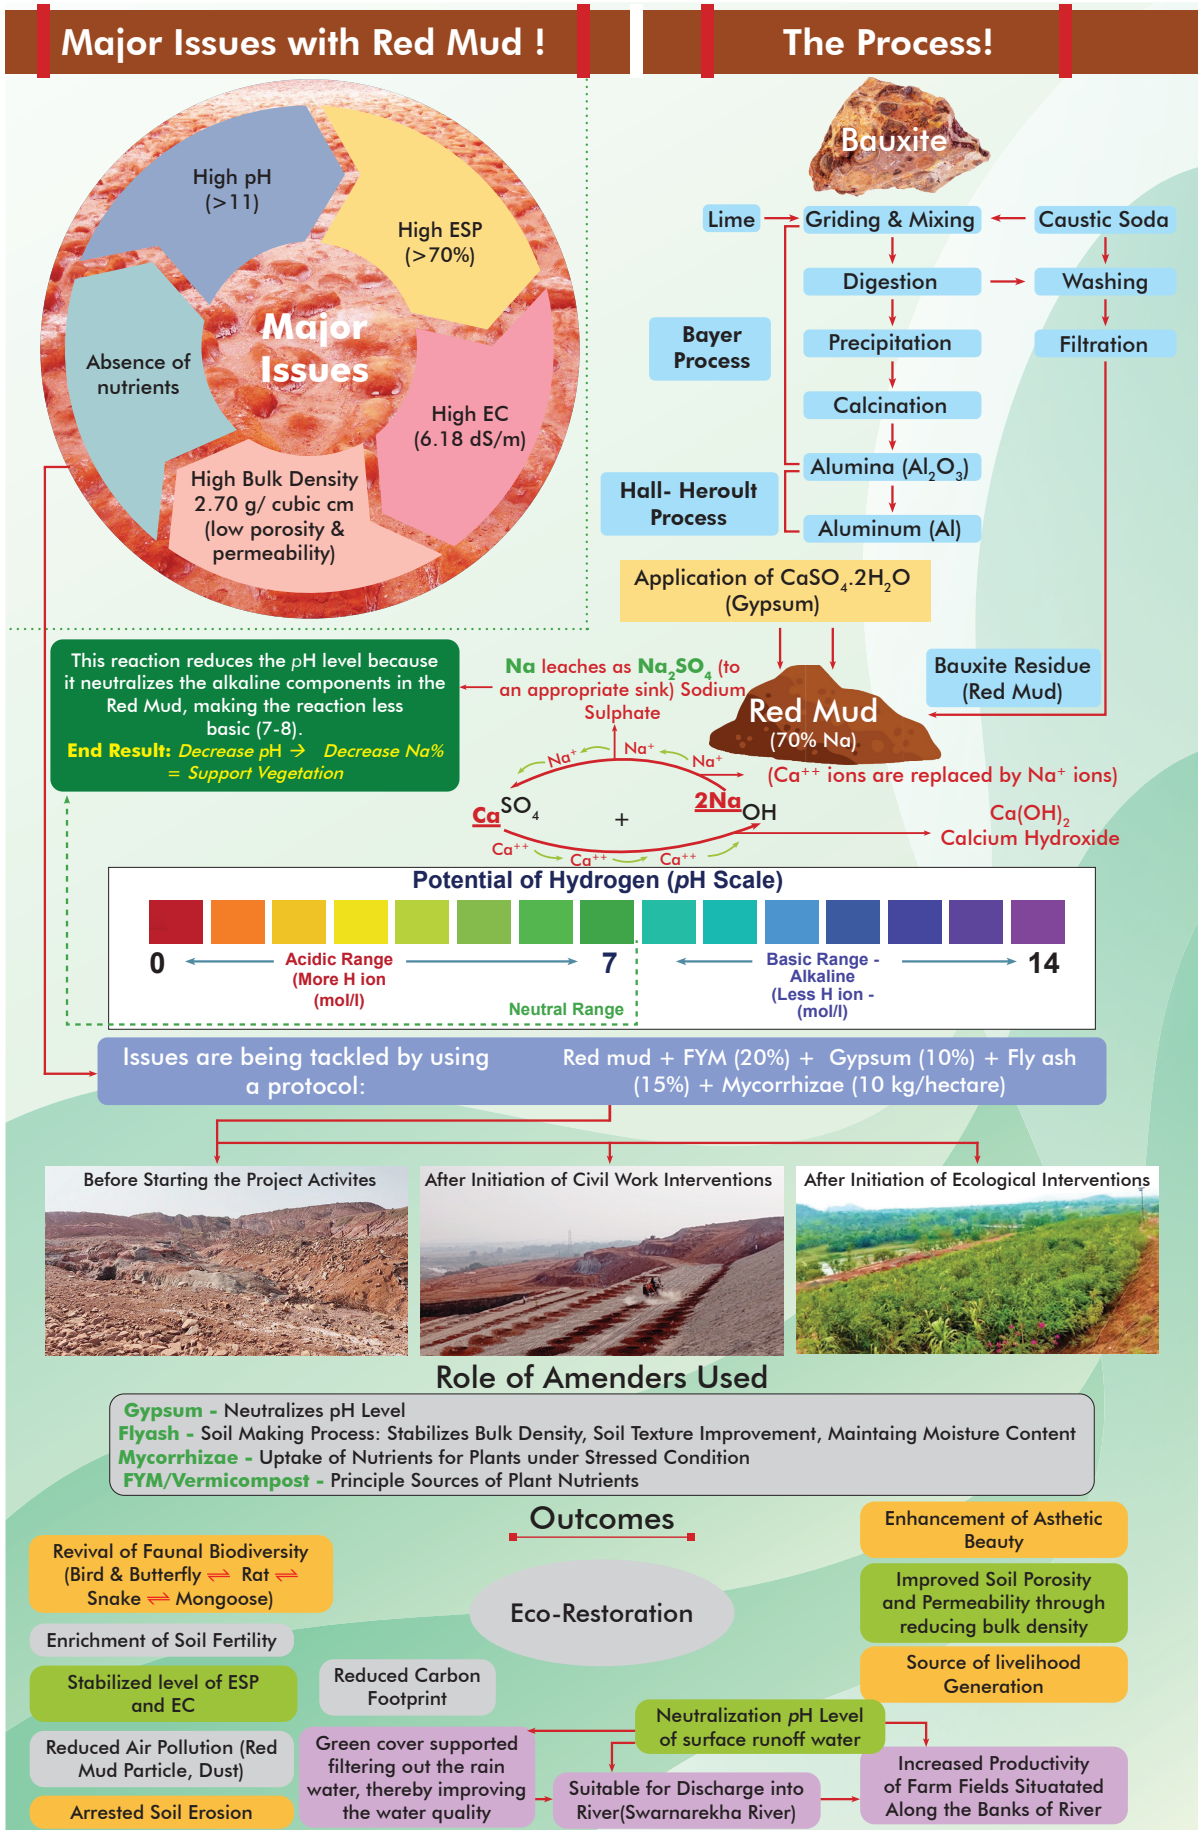
Figure 2: Major issues with Redmud and process of revival of degraded ecosystem through ecological intervention

Red mud, a byproduct of aluminium production, has a pH of over 11 due to high sodium content. Its poor substrate properties prevent plant growth, while during the dry season, red mud particles become airborne, and in the wet season, soda leaches into groundwater. These challenges made the land unproductive and environmentally hazardous.

The project focused on rehabilitating the red mud dump area by converting the highly alkaline red mud into a more hospitable substrate capable of supporting vegetation. This was achieved through various physio-chemical treatments and landscaping activities to mitigate environmental degradation and prevent pollution from the red mud, which is a byproduct of bauxite mining. TERI's approach involved the following multiple interventions:

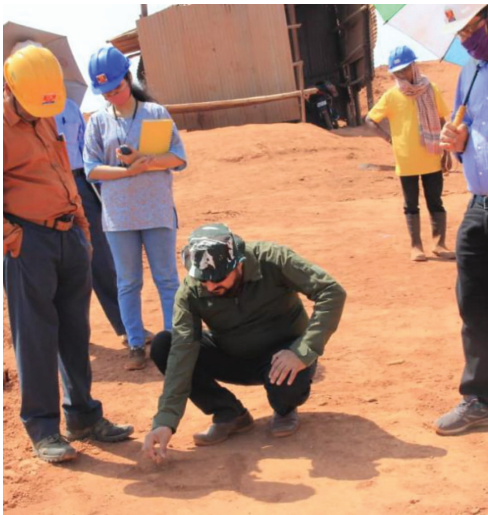
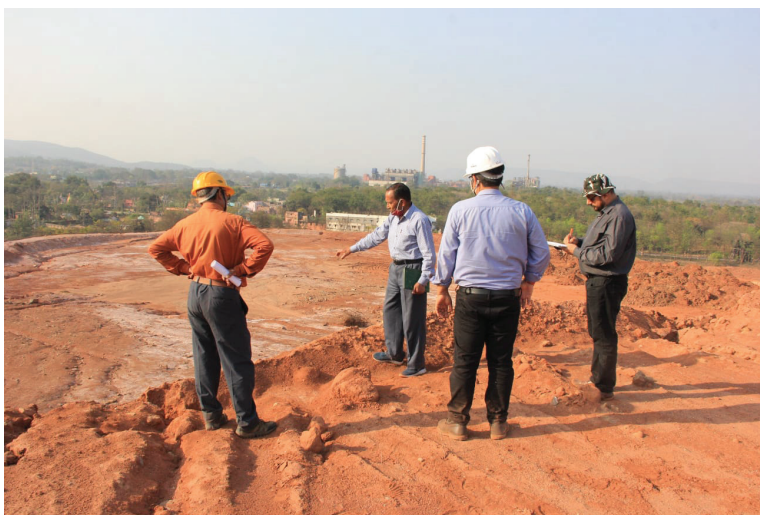
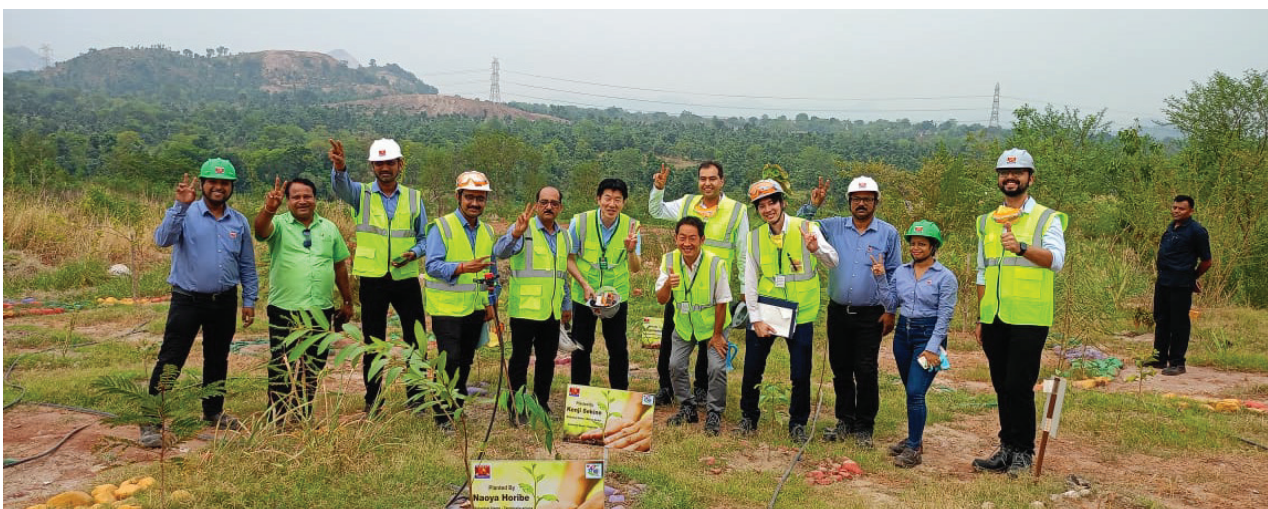
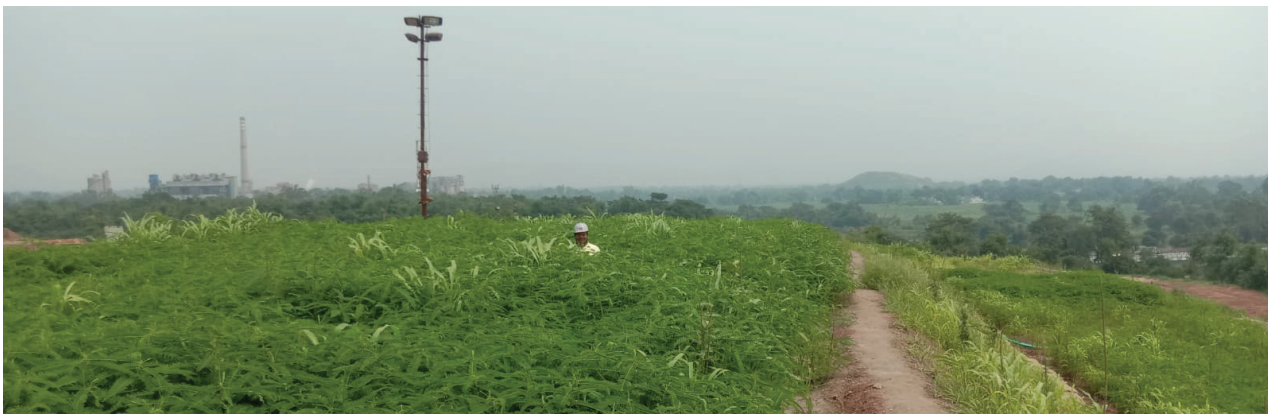
Glimpses of redmud rehabilitation activities
